Medieval Monasteries.

Parish of Bagenalstown

CARA DÉ

Augha

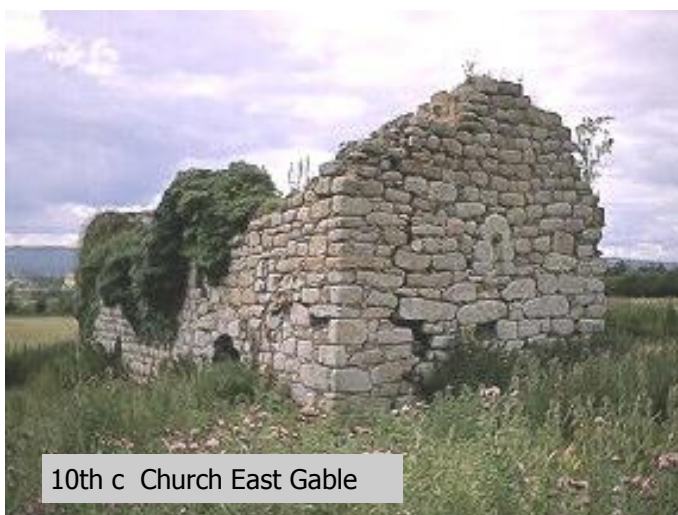
10th c Church East Gable

In ruins. East and west gables and south wall extant, north wall collapsed completely.

This church was built in two stages. Earliest stage at West side has stonework of exceptional quality (hammer dressed.), with L/W ratio of 2:1. The later extension making L/W ratio 3:1 stonework is much inferior.

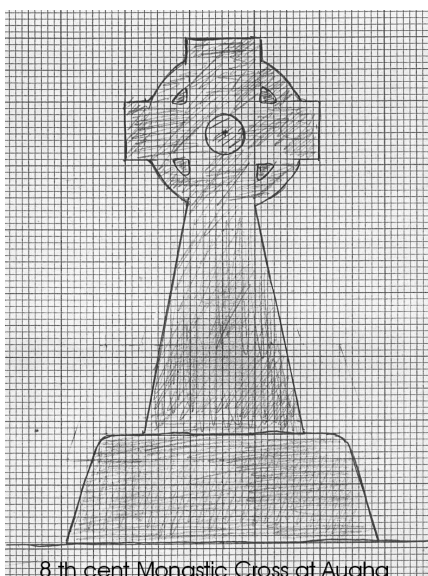
8 th cent Monastic Cross at Augha

Artists reconstruction of 8th c granite cross in graveyard, extrapolated from base dimensions and by divining. The cross is similar to others of same period locally eg Killeogan & Old Leighlin.

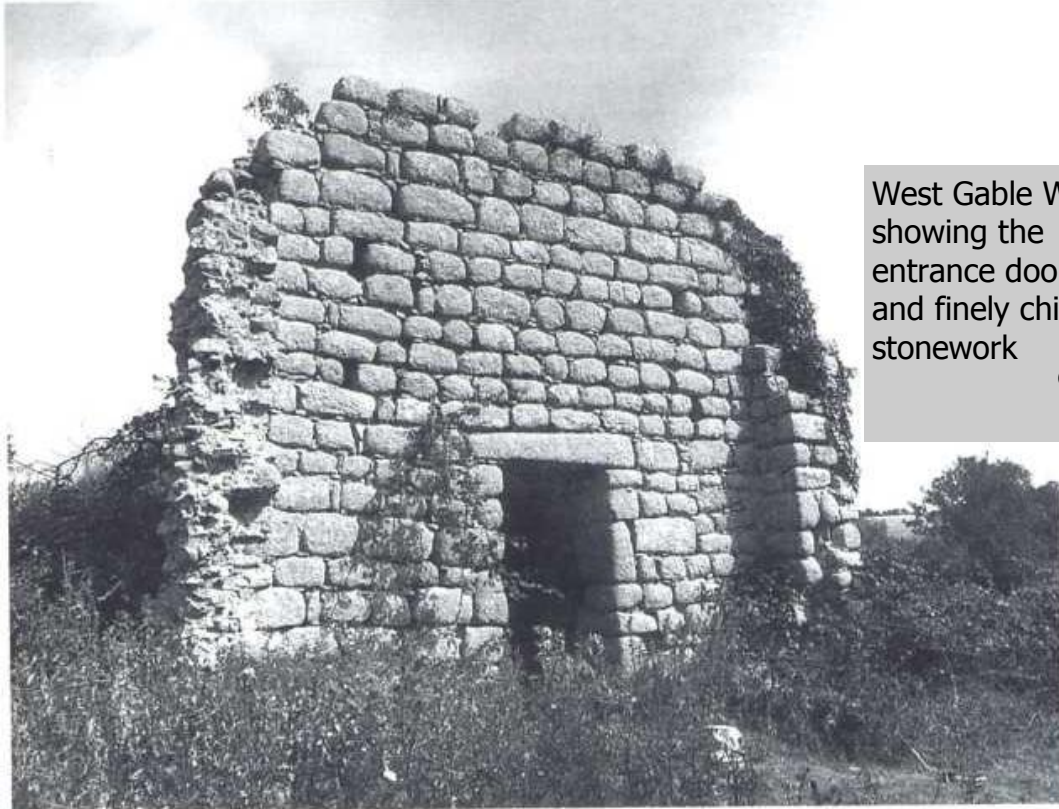
O.P.W Photo

West Gable Wall showing the main entrance doorway and finely chiselled stonework

Trabeate lintelled door in centre of W gable. Anta with base batter preserved at SW corner. NW angle has collapsed. Two cross bases: (1) very regular slightly pyramidal rectangular granite block with rectangular socket and tapering mortice; (2) large thin rectangular granite flag, with rectangular socket; comparable shape to late medieval wayside crosses in Co. Kildare. (Gwynn and Hadcock 1988, 372)

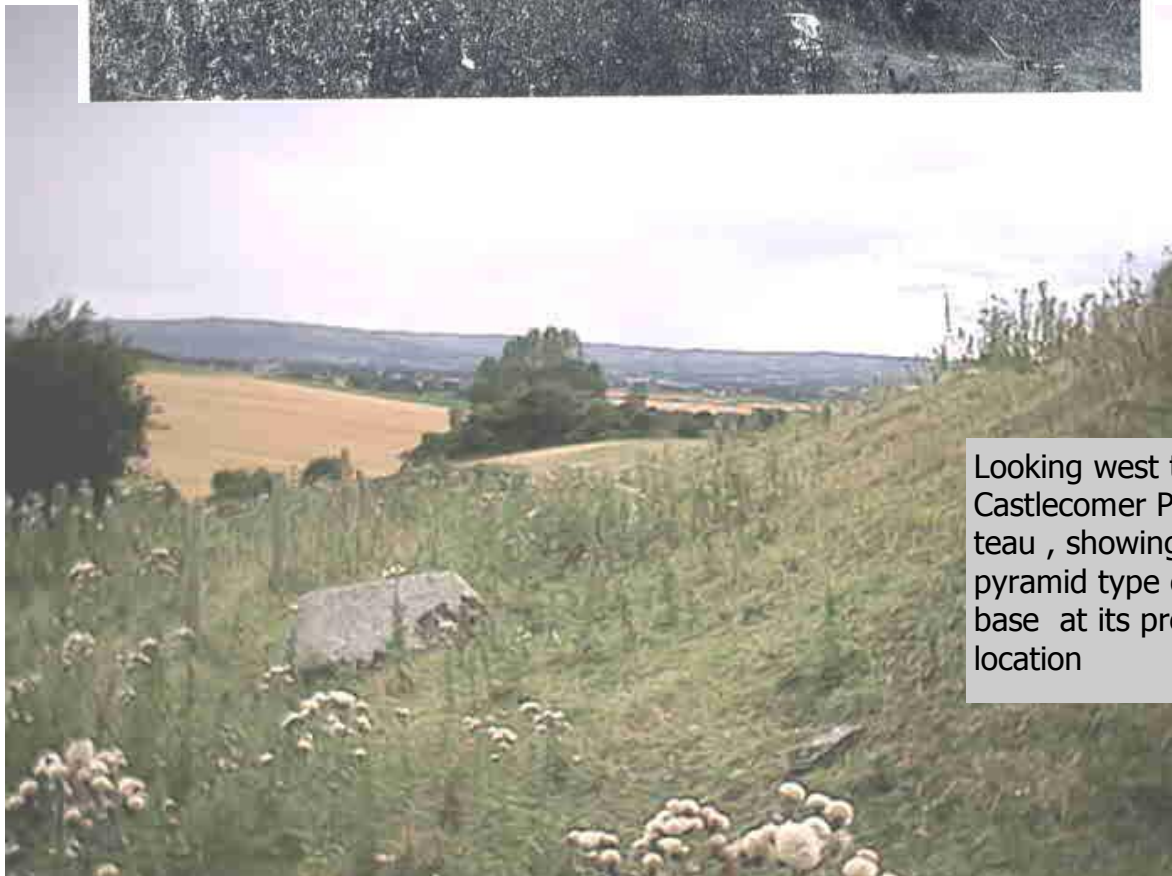
Looking west to the Castlecomer Plateau, showing the pyramid type cross base at its present location
